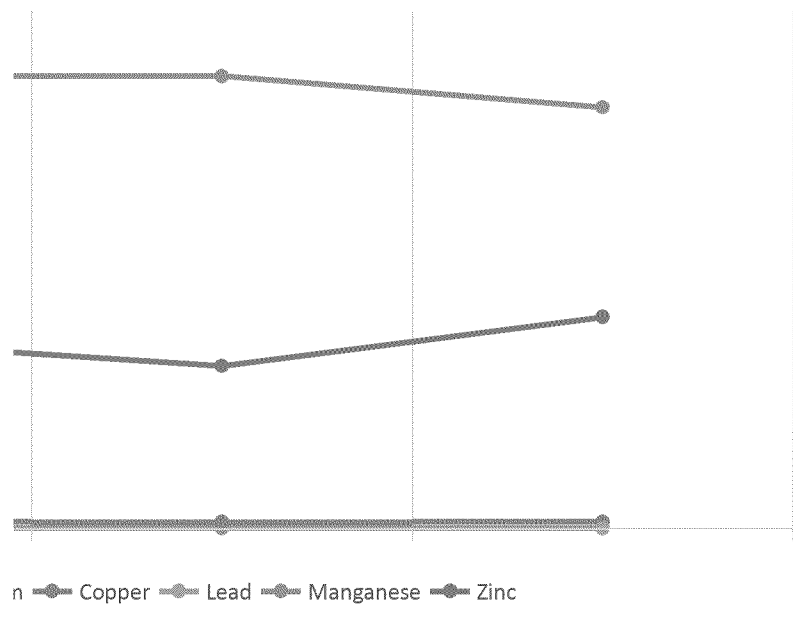
Location: 32nd Street Bridge

ocation ID	Date Sampled	Cadmium	Copper	Lead	Manganese	Zinc
32nd St Br	8/5/2015	0.178	1.7	0.24	105	43.5
32nd St Br	8/6/2015	0.16	1.56		105	37.8
32nd St Br	8/6/2015	0.19	1.62	0.115	97.8	49.1
